## Bridge of the Month No79, July 2017 Framwellgate, Durham

And now to the magnificent Framwellgate bridge. If you don't know [Durham](#), it is well worth an outing with two big medieval bridges and magnificent cathedral, plus a railway viaduct that will feature here soon. The two bridges, Elvet and Framwellgate carry a now pedestrianised road across the narrow neck of land which isolates the castle and cathedral in a loop of the River Wear. Elvet has a row of modest pointed spans but [Framwellgate](#) crosses the river in two enormous segmental arches declared to be 26.5 and 25.1m span. There is actually a third, much smaller, span on the city side which is now hidden by surrounding buildings (to the right in this picture from the upstream side). Even in early summer it is impossible to get a complete view of both main spans.

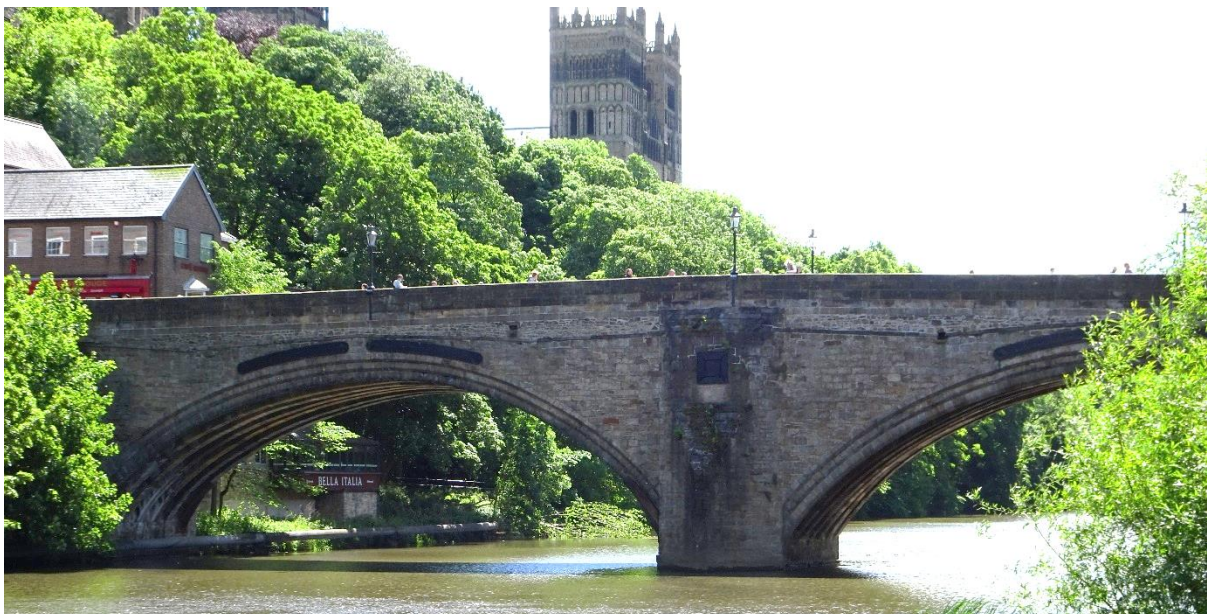
The downstream side shows rather more interest than upstream, at least initially.

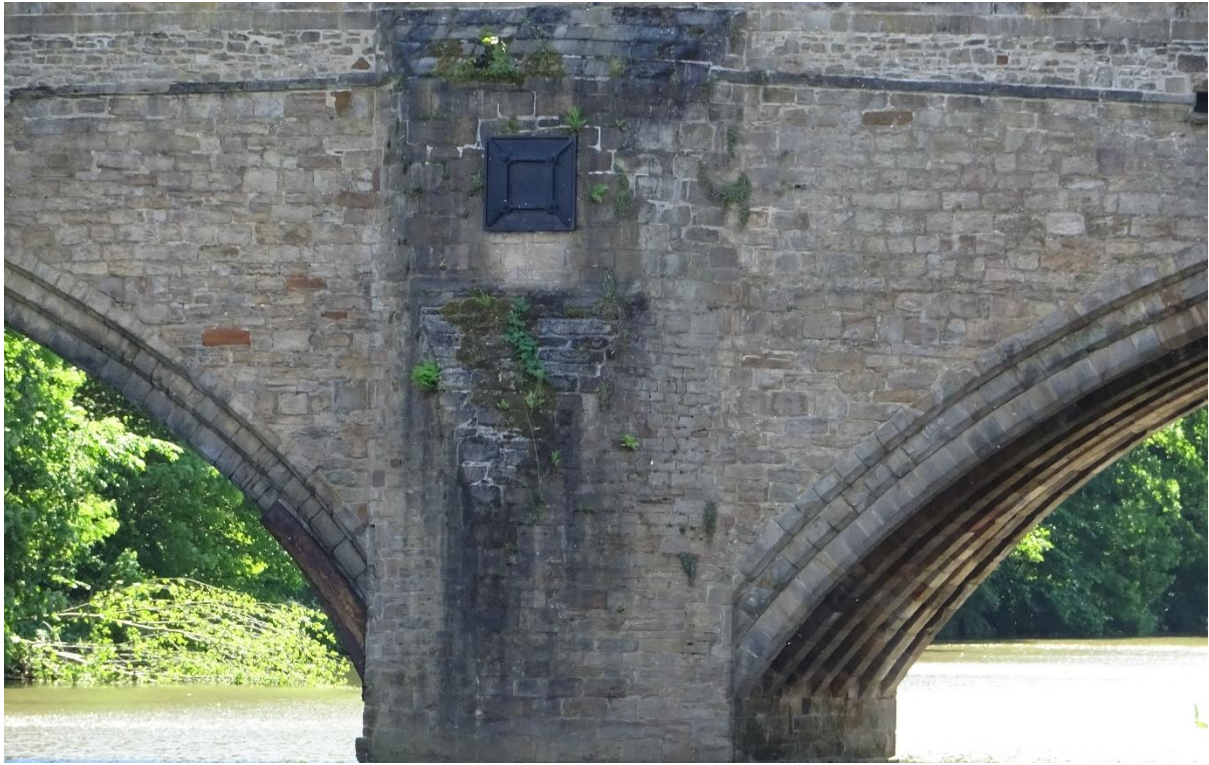
I am sorry that, in a hasty visit, I managed to decapitate the cathedral but note the rise and fall of the string course here. This clearly follows the medieval road line.

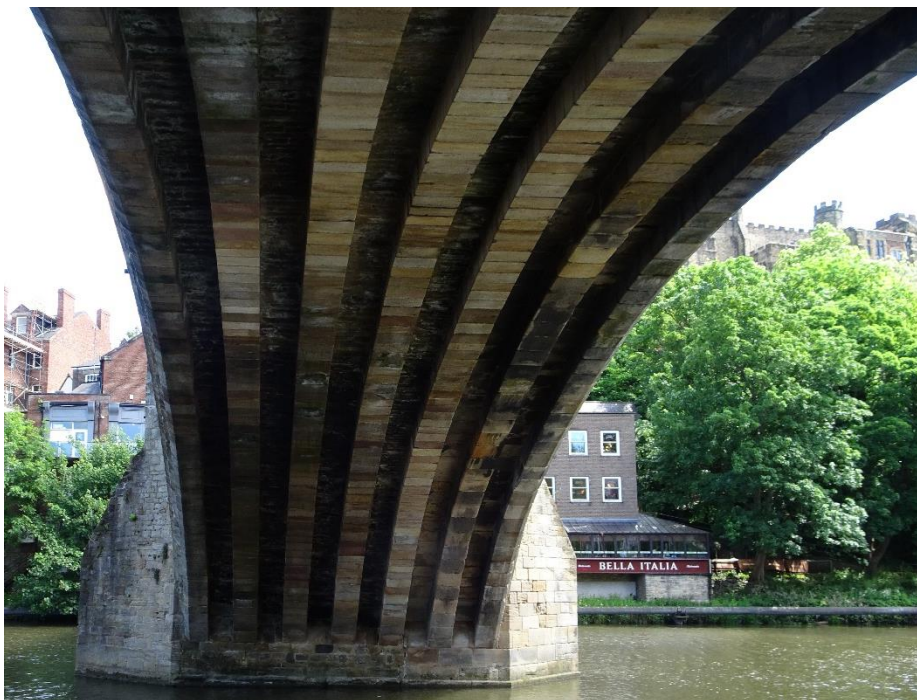
The arch ribs are chamfered on the outer face only. The inner ribs are square edged.

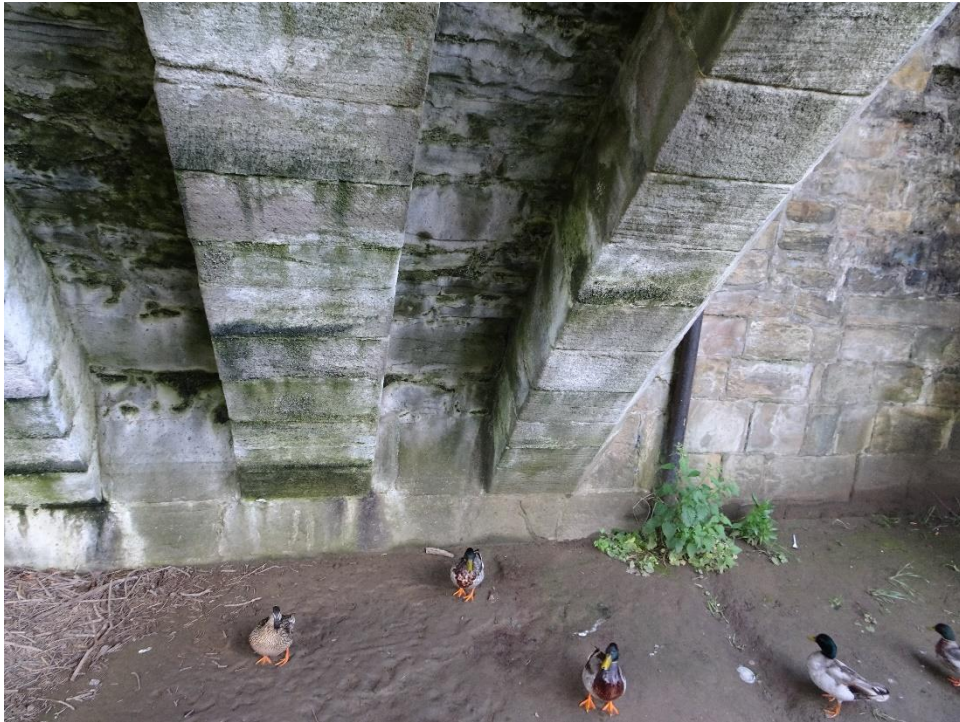
One indicator is the infill between the ribs. In the older part it is of random shape and size stones.

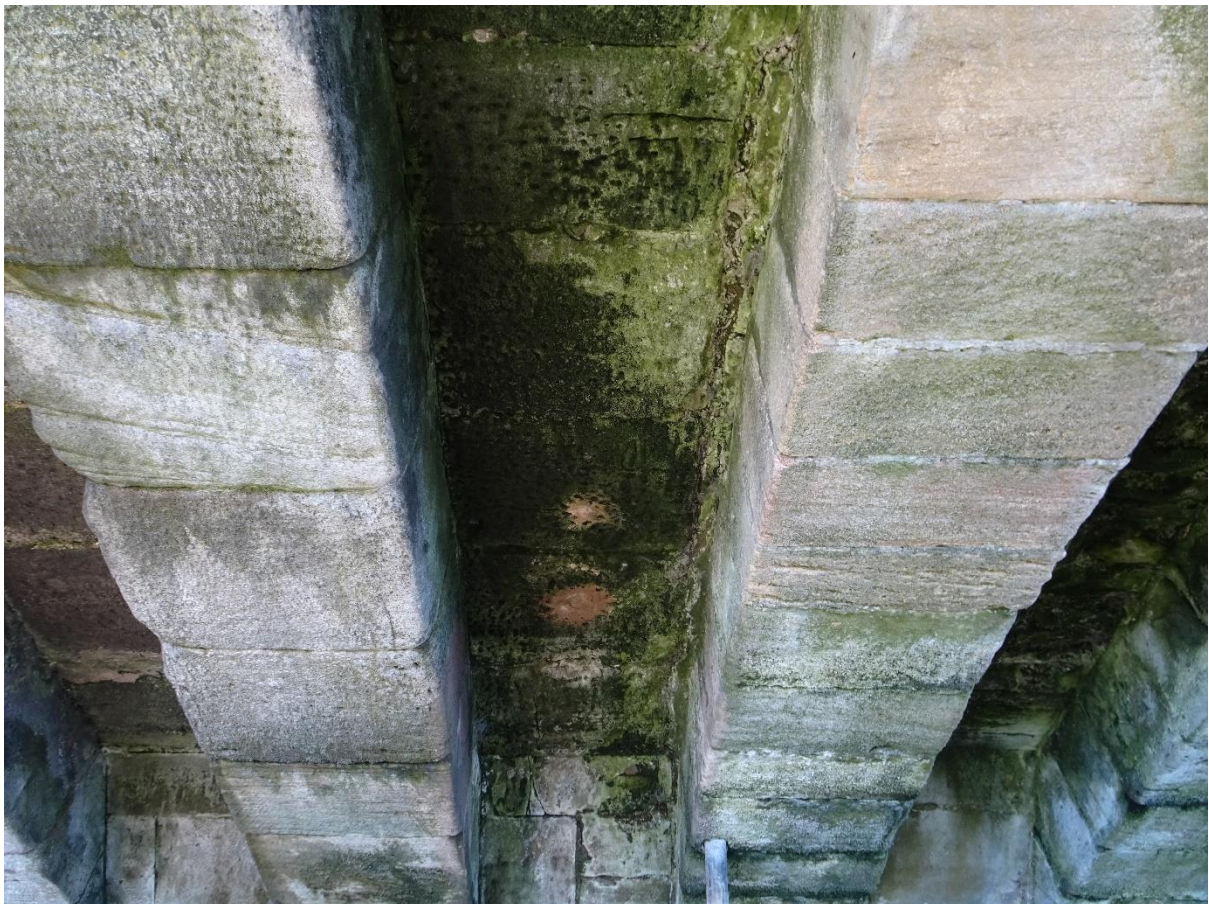
Beyond the join the stones are much larger, but the joint is actually visible here and the rib at the olde edge (right) is square edged.

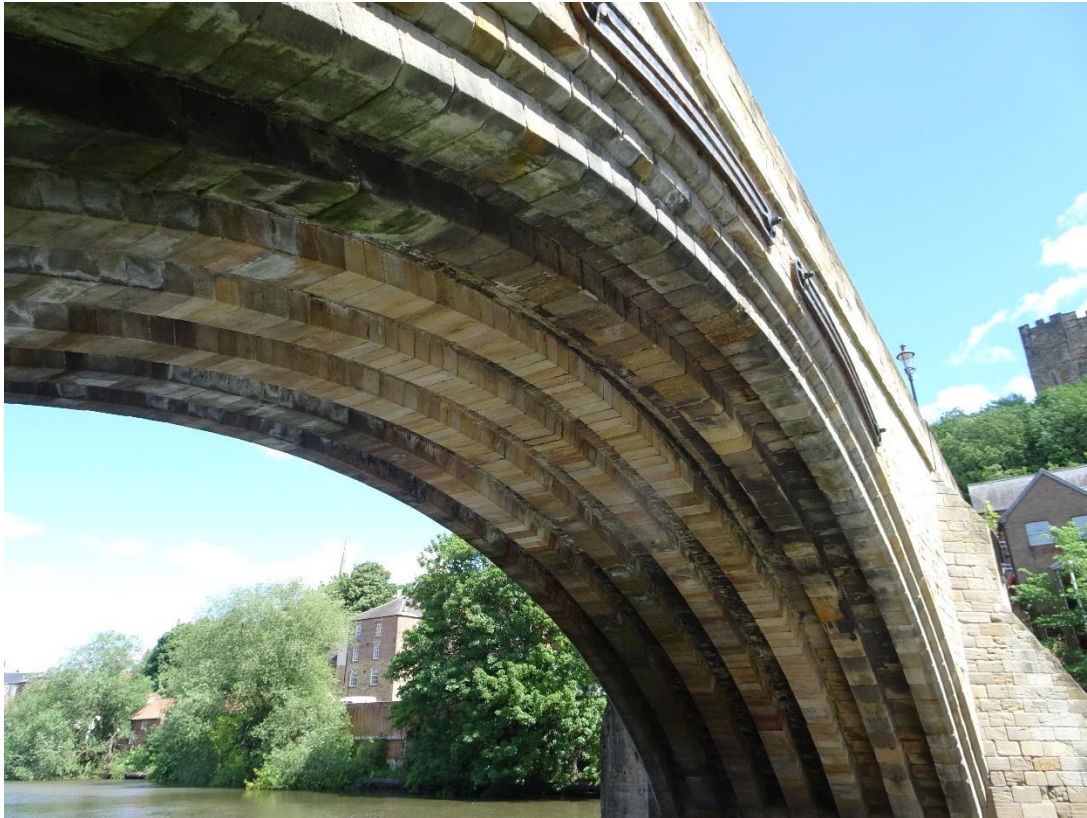
Look up to the crown and it becomes even more interesting.

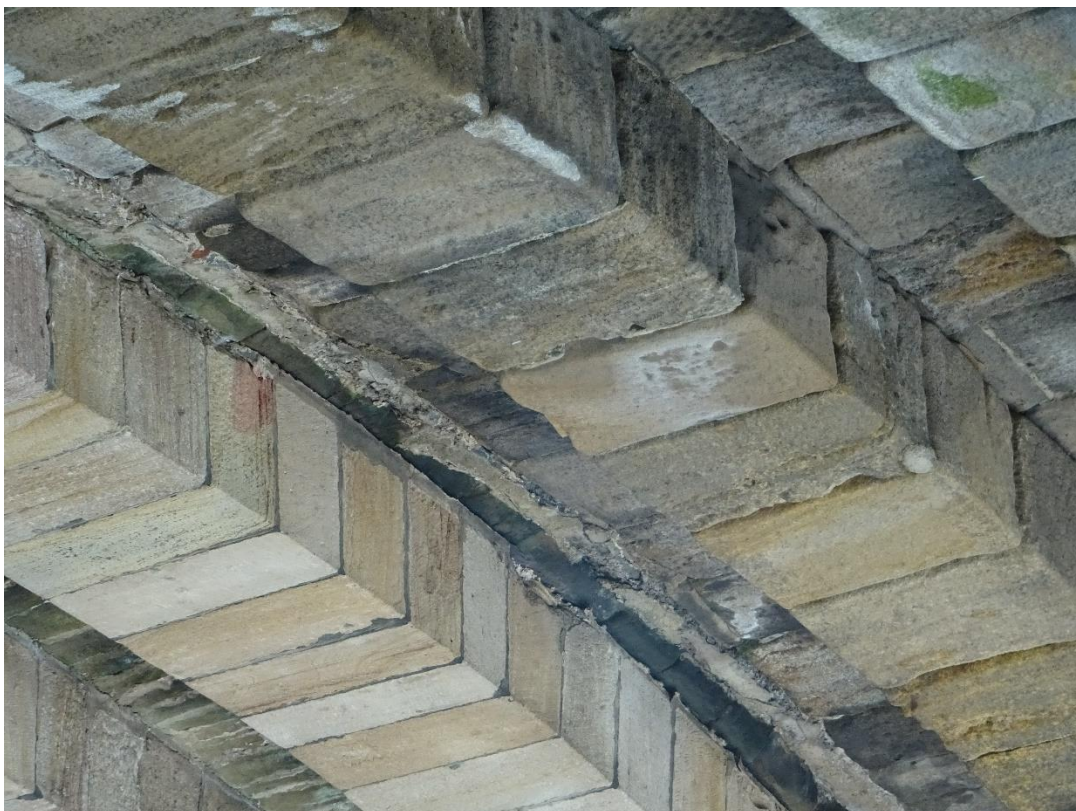
Look closely and it is obvious that the original ring was removed and replaced to be reused on the new downstream face, preserving the appearance of the bridge as much as possible.
