Bridge of the Month No83, November 2017 Bendy Bridge in DentDale

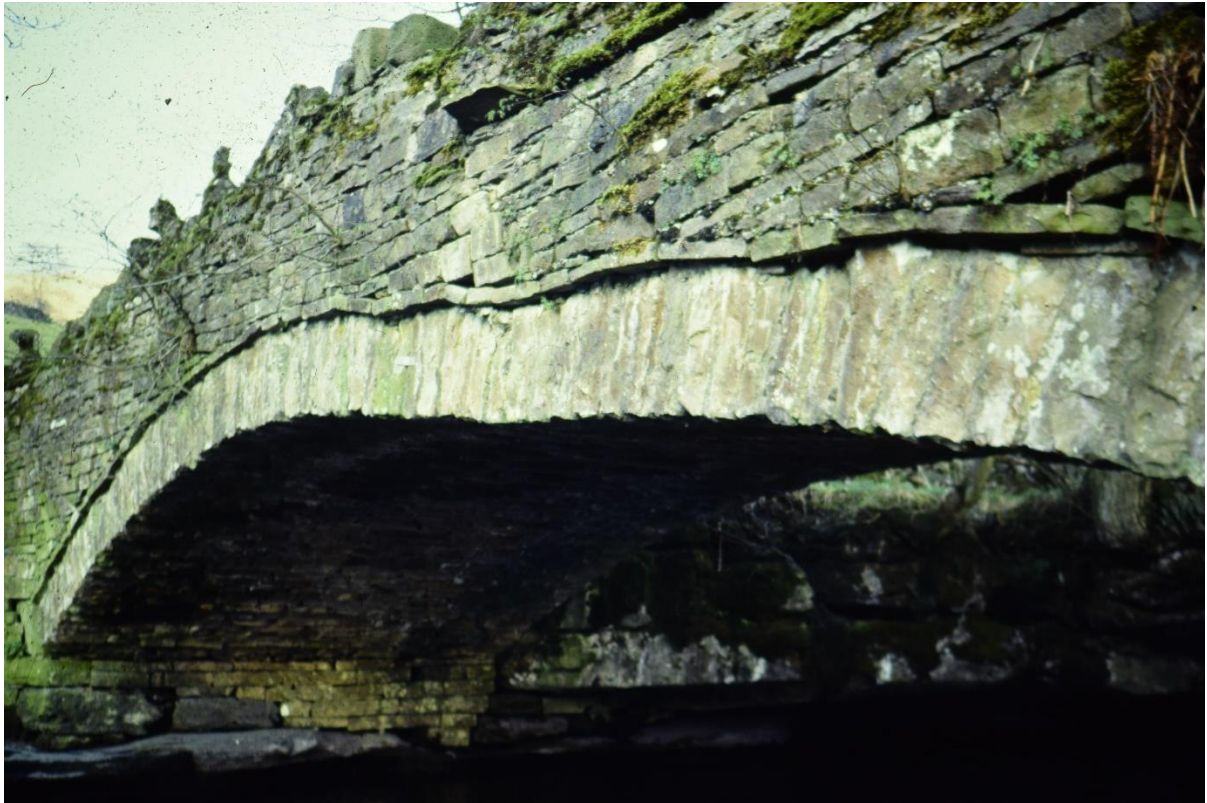
This delightful [bridge in Dentdale](#) is long gone. The pictures surfaced in a collection of slides I had copied recently. The arch began fairly flat and long with negligible cover. When I first saw it back in the 70s it was already distorted but still in use. I went round that way deliberately to get a fresh photo and was sad to find it had given up. Perhaps the farmer moved on from his little Fergie and the bridge couldn't deal with it.

- 1) Masonry bridges are NOT brittle. They will bend dramatically before failure, redistributing moment in a way analogous to continuous steel or (well designed) concrete beams.

- 2) If you look closely, you will see a telltale at mid span, at mid depth of the ring. The damage that is taking place is a long way away from there. The question that is so rarely asked "Is it a fair test?" hasn't been asked here. Measuring something that is unlikely to change is not a very useful way forward when there is obviously major change taking place elsewhere.

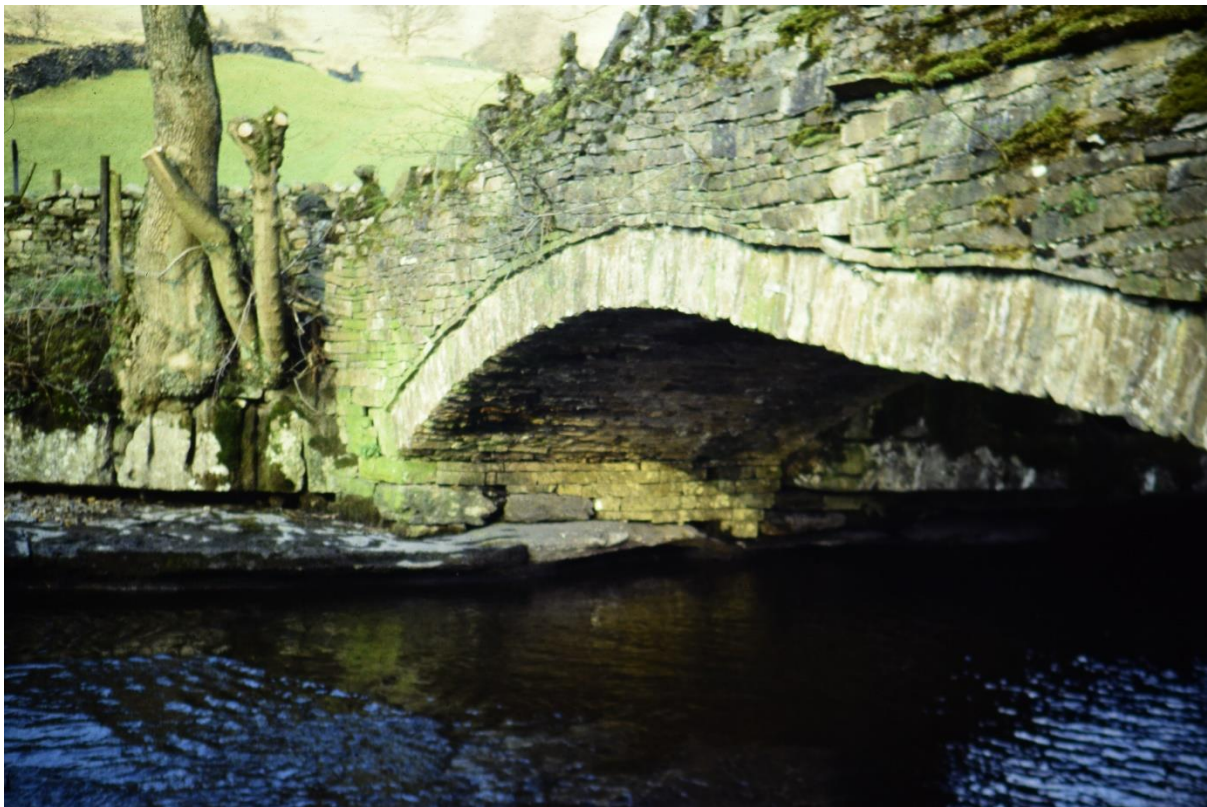
- 4) If you look at the second photo you will see that the courses in the spandrel wall/parapet sweep upwards towards the crown. So they haven't been rebuilt since the movement, or at least, the movement has increased considerably since they were rebuilt.

- 5) The line of projecting stones in the parapet suggests that there has been at least some rebuilding.
- 6) Photo 4 shows the replacement bridge with an arched steel beam deck but still stone parapets. One wonders whether it will last as well as would a rebuild with the original materials

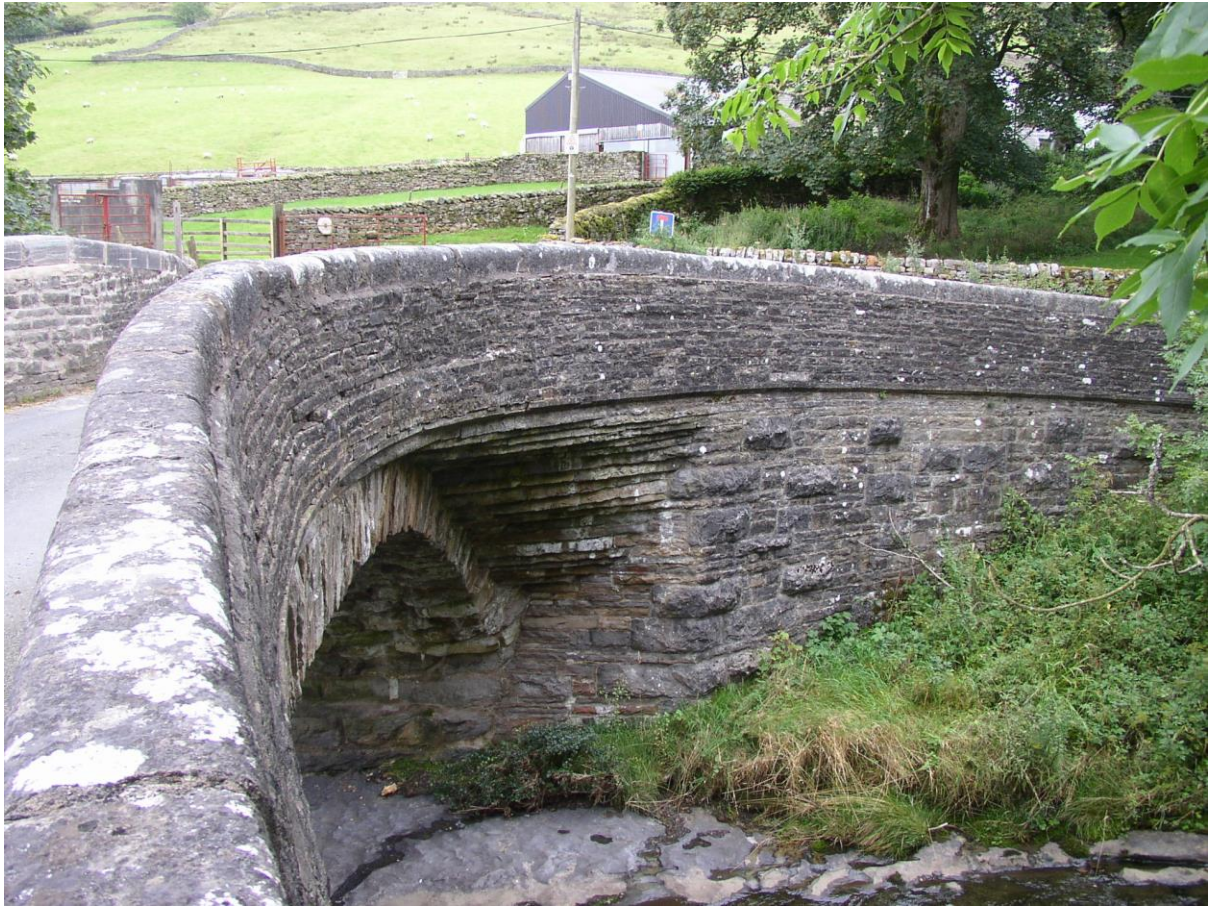
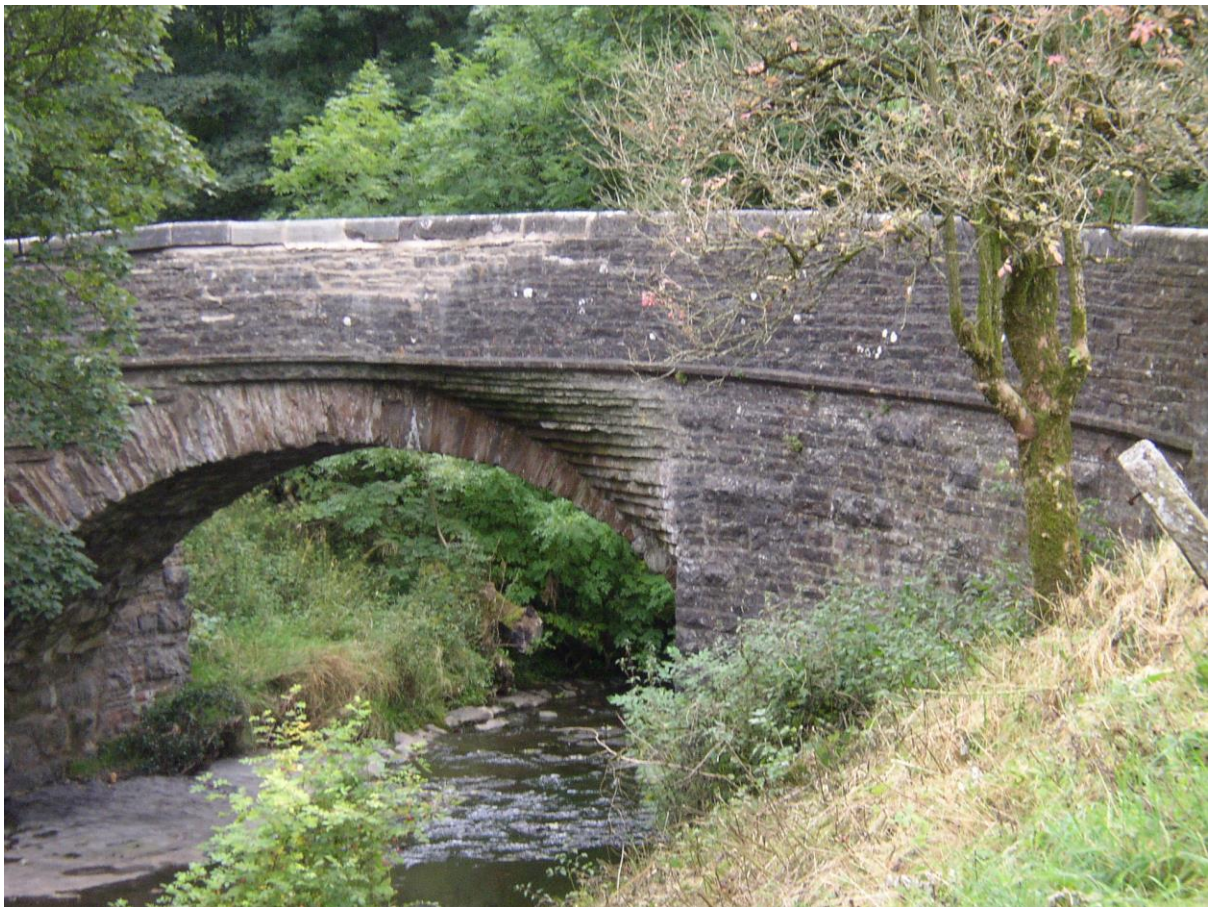
- 7) Photos5&6 show an essentially similar bridge (though with a somewhat higher rise) carrying the public [road further up the dale](#). The squince in the corner allowing the bends to be softened a little make driving noticeably easier, even in a car. It must be transformative for a truck. The main point here, though is that this bridge does carry road traffic and has no known weight limit.
